## Structural Assessment Report

100 SW 83 WAY BLDG 02  
PEMBROKE PINES, FL 33025

**RE:** Structural Assessment Report with respect to the property located at:  
Final Report  
100 SW 83 Way  
Pembroke Pines, FL 33025

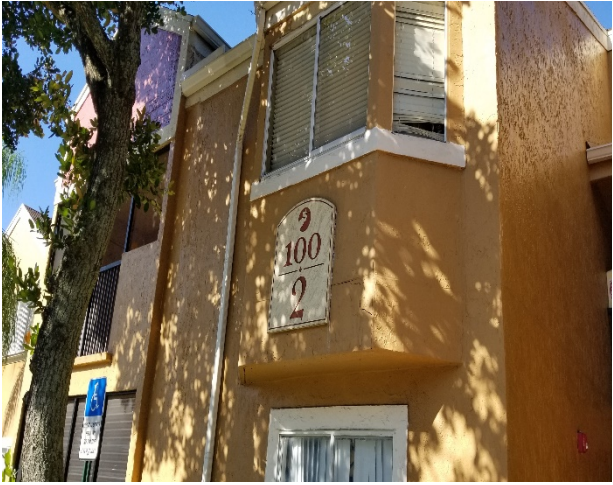
**Photograph 1: Building elevation. Balcony wall cracking**

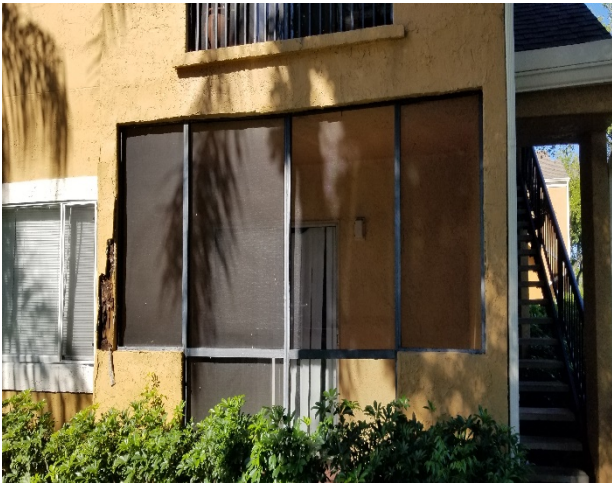
Wood column in Unit 104 was found to be in poor condition compromising the safety of the residents. Temporarily shoring system must be installed in accordance with plans and specifications. Not included as part of this report.

**Photograph 3: Unit 104. Shoring required**

1. Temporarily shoring system in accordance with the plans and specifications must be installed immediately to support deteriorated column in Unit 104.

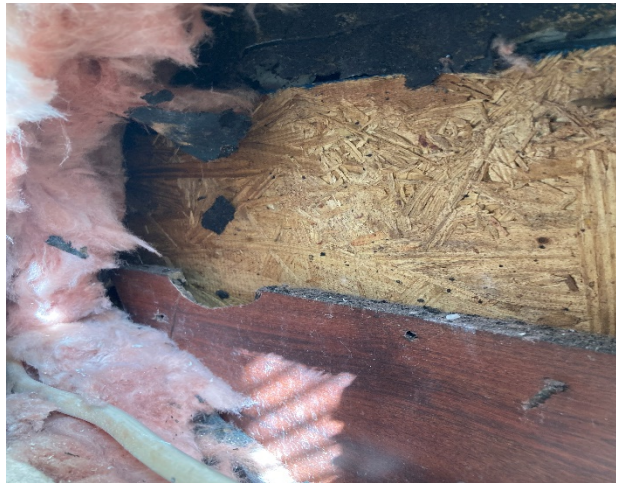
**Photograph 4: Unit 101**

Residents of several first-floor units reported multiple previous plumbing or a/c leaks underneath bathrooms and air handler closets of the second-floor units. In addition, at the time of this assessment, unit 101 Building 10 wood floor framing was exposed throughout the unit.

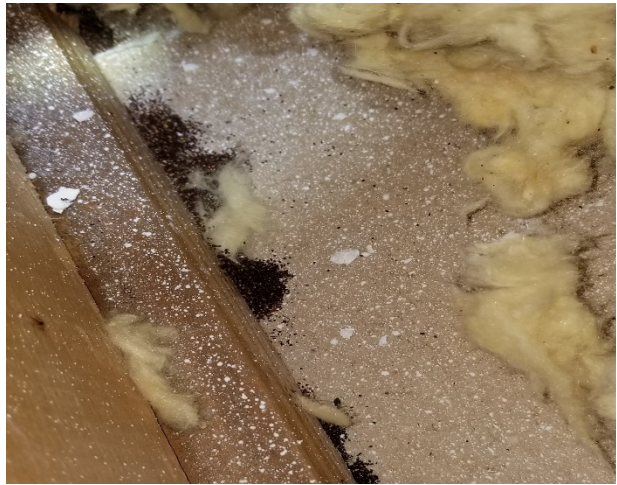
**Photograph 8: Unit 202. Termites infestation in the attic**

9. The entire building must be treated for termites prior to the repairs and inspected again for termites following the repairs. If termites persist, the building must be treated again.

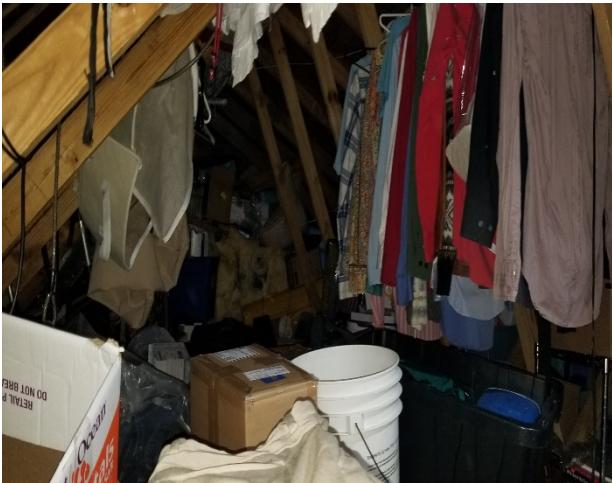
**Photograph 9: Unit 204. Household item within the attic space**

6. All household items stored in the attic space are a fire hazard and must be removed.
7. All staircases must be cleaned from corrosion, welded as needed, and painted. All cracked concrete steps must be replaced.

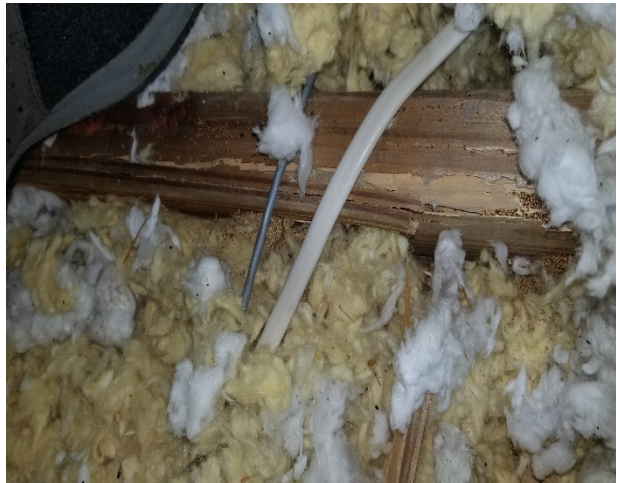
**Photograph 10: Unit 205. Termites infestation and damage to bottom truss chord**

4. The floor flat trusses must be exposed in all bathrooms and air handler closets. All moisture damaged framing must be repaired.
5. The insulation within the attic space must be vacuumed and all bottom chords of roof trusses must be inspected and repaired if found structurally damaged.

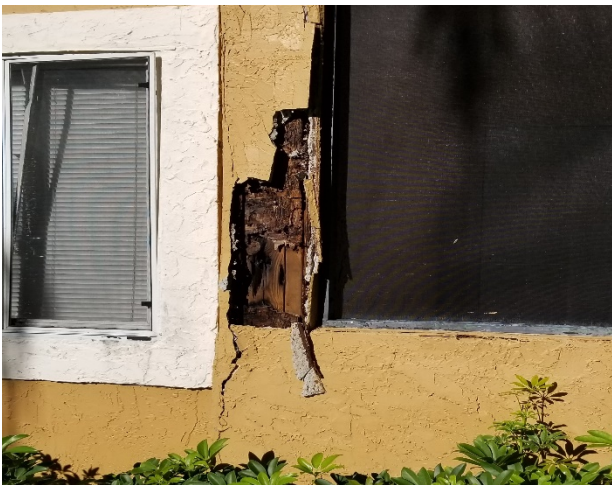
**Photograph 11: Opening in the exterior wall**

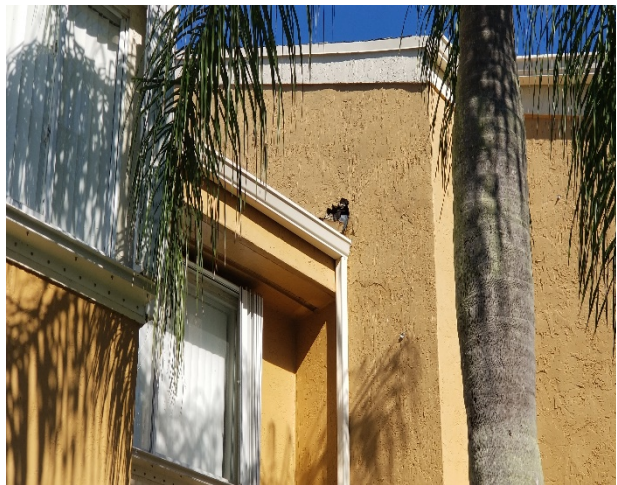
**Photograph 12: Opening in the exterior wall**
