## Structural Assessment Report

100 SW 83 WAY BLDG 02  
PEMBROKE PINES, FL 33025

**RE:** Structural Assessment Report with respect to the property located at:  
Final Report  
100 SW 83 Way  
Pembroke Pines, FL 33025

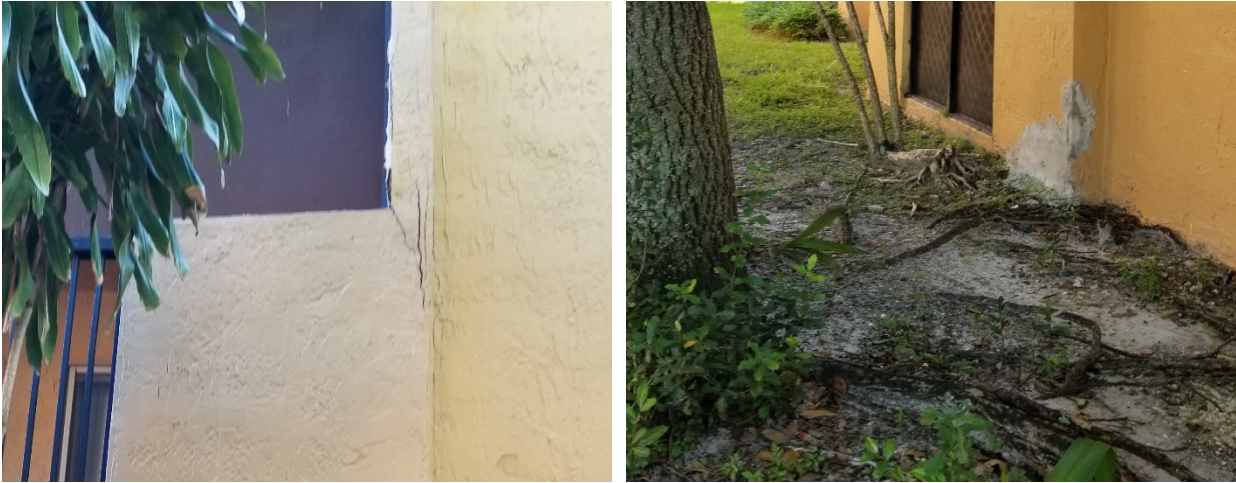
**Photograph 12: Opening in the exterior wall**

2. Stucco along the perimeter walls must be stripped to the wood sheathing along the entire building.
3. The areas showing deteriorated sheathing and/or wood studs must be replaced. The remaining visibly sound structural framing must be evaluated by a special inspector.
